DAMAGE EVALUATION IN COMPOSITE LAMINATE BY THE USE OF ULTRASONIC LAMB WAVE

Abstract:

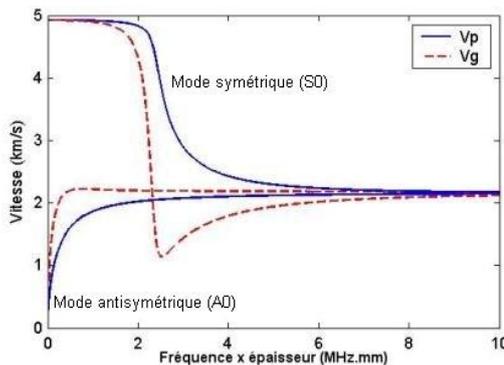
Figure 1. Dispersion curves for an 8 layer laminate composite

The angle of incidence for generating Lamb waves is given by (3) as shown in *Figure 2*, where V_L is the incidence compression velocity, θ is the incident angle and V_p is the phase velocity of the Lamb waves along the plate. Lamb waves therefore can be generated by mode conversion. The phase velocity for a particular mode depends on the angle of incidence, the incident wave frequency and the thickness of the plate [8]. For a fixed plate thickness and frequency, selected modes of Lamb waves can be obtained by varying the angle of incidence of the transmitter. *Figure 1* shows the Lamb wave dispersion curves for the laminate composites used in the experiments described in this paper [9]. There are only the fundamental symmetrical S_0 , and asymmetrical A_0 modes. The A_0 mode is dispersive with the phase velocity increasing asymptotically to a constant value near to the Rayleigh wave velocity. The S_0 mode is constant up to about 2MHz×mm where it decreases sharply thereafter and tends to the same constant value as the A_0 mode. The non-dispersive S_0 mode from 0 to about 2MHz×mm can be used for defect detection. By choosing an appropriate angle of incidence the S_0 mode can be generated in the plate.

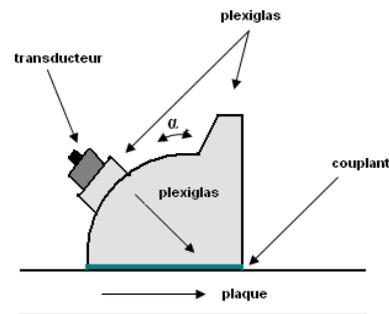
Figure 2. Generation of Lamb waves.

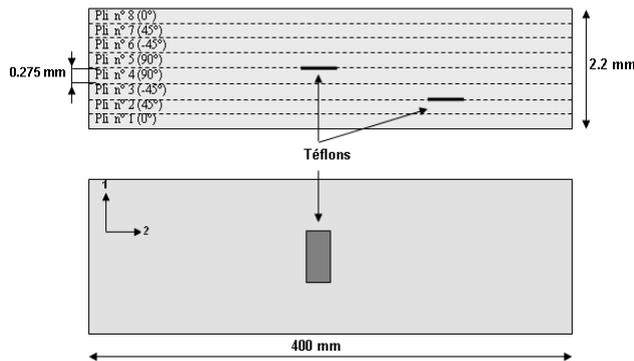
Figure 3. Typical location and size of delaminations

Artificial defects (delamination 20mm×30mm) were inserted between the adhesive film and the substrate. Each of the included defects simulates a different type of flaw that could appear on the assembly line. Some pieces of Teflon film, peel ply or separated film were inserted between 2^{ed}/3rd ply and between 4th/5th before bonding. *Figure 3* shows a typical specimen dimension with the tow simulated delamination sizes.

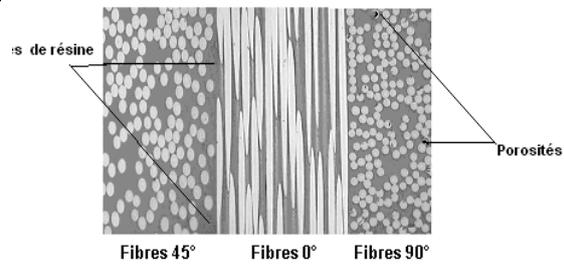
Figure 4. Microscopic observation

Optical microscope has been used to observe the different orientations of carbon/epoxy fibers. The obtained micrographs are illustrated in *Figure 4*. This observation shows the presence of three orientations of fibers layers oriented at 0°, 90° and those oriented at 45°.

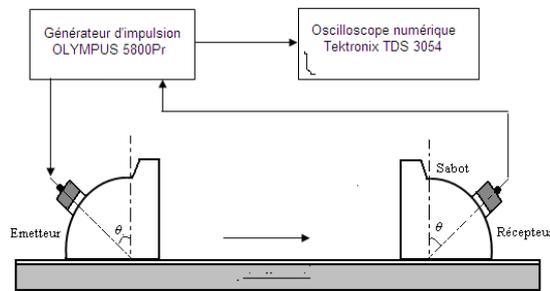
Figure 5: S_0 Lamb wave mode generation and detection.

Figure 5 illustrates the experimental set-up for Lamb wave generation and detection. A variable-angle-beam transducer consisting of a broadband transducer element (0.5 MHz, Panametric) and a Perspex wedge (ABWX-2001, Panametric) was used as the ultrasonic transmitter to excite Lamb waves. In order to generate a pure S_0 mode, the angles of incidence were determined by Snell's law as (3) [8]. Both the transmitter and receiver were mounted on the surface of the laminate via a coupling gel, separated with a distance of 100 mm. A pulse generator (5800Pr OLYMPUS), is used to provide electrical power in pulse duration of 5 μ s. The detected signals were amplified and transferred to a digital oscilloscope (TDS 3054, Tektronix), which carried out 100 averages to improve the signal-to-noise ratio.

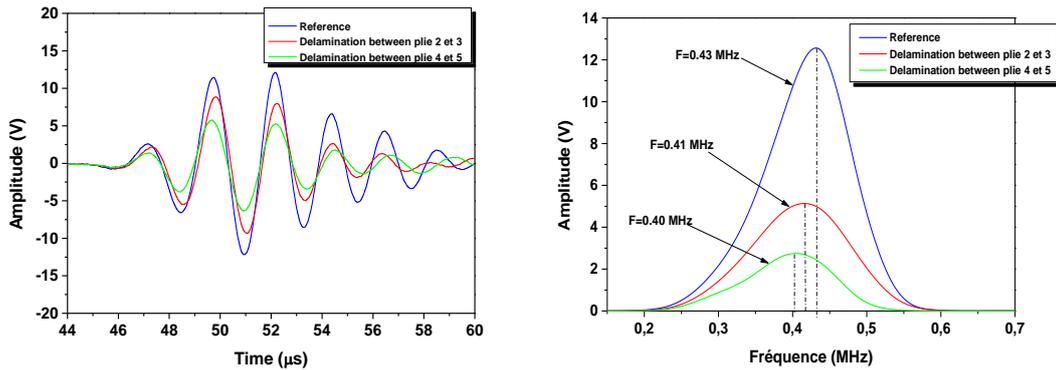
Figure 6: Waveform detected of tow different delamination

The transmitter and receiver were then positioned at a defect-free area adjacent to where a delamination was situated. We obtain a reference signal which corresponds to the S_0 Lamb mode in an area. Then again take the signal obtained with two artificial delaminations. From time signals we can draw the corresponding frequency spectra.

When Lamb wave incident meeting a defect delamination near the surface (between the second and 3rd folds), it is possible to observe a decrease in amplitude of the received signal and a shift frequency to the left. This reduction is due to the separation of the wave front to delamination, and a major portion of energy is drawn by thicker sections of the laminate. The signal is taken just above a shallow delamination (between 4th and 5th plies), a significant decrease in amplitude was noted. The S_0 mode velocity was first measured before the inspection. Knowing the difference in time of flight between the transmitter and receiver respectively taking two different distances, then you can eliminate the time course in the hooves, so we obtain the wave velocity. The measured and predicted wave velocity is listed in *Table 1*. The predicted wave velocity was in good agreement with those measured for laminate.

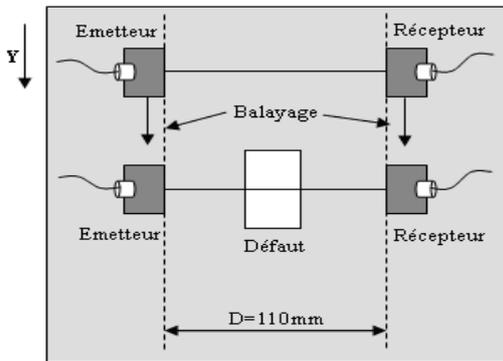
Figure 7. Schematic representation of line-scanning method

In order to detect and identify delamination, and evaluate its size and location, a new method using Lamb wave velocity and attenuation was developed [10]. The method illustrated in *Figure 7*, consists in comparing the signal amplitude inspecting delamination. The transmitter– receiver system is moved in a line parallel to the Y axis containing the major axis of the delamination. The objective inspection area within the plate was 110 mm long and 200 mm wide. Experimental results of the transition of the normalized maximum amplitude of the earliest wave packet are provided in *Figure 8*. A sudden change (decrease) in the maximum amplitude of the earliest wave was observed in the presence of the delamination, and the lower amplitude was maintained even beyond the delamination. We could therefore estimate the detectable delamination length about 27 mm. These experimental results show the feasibility of foam damage detection using Lamb waves. However, we could

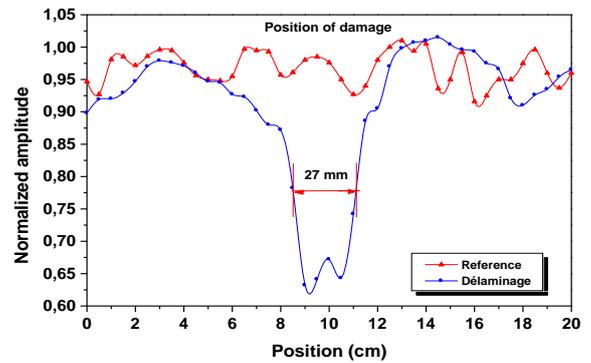
Figure 8. Normalized amplitude measurements

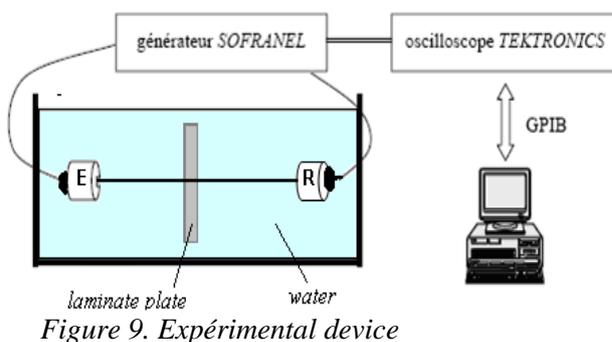
Figure 9. Expérimental device

We performed a conventional C-scan to validate the present method. Two piezoelectric transducers (9.5 mm diameter with a center frequency of 5 MHz) were positioned face to face. The distance between the two devices is about 4 cm. The composite plate was placed on a XY motorized table. The receiver transducer measures the transmitted signal through the plate and the maximum of the amplitude was stored by a computer. The inspection area was 90 mm 90 mm, including the delamination, and was scanned in steps of 2 mm. Figure 10 presents the C-scan image depicting the delamination. We confirmed that the delamination was nearly rectangular 15 mm long and 25 mm wide mm so we demonstrated that the present method accurately evaluated the size and location of delamination.

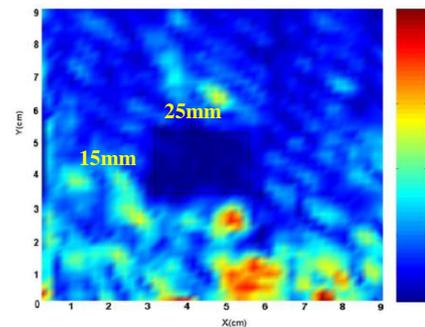
Figure 10. C-scan image of delamination

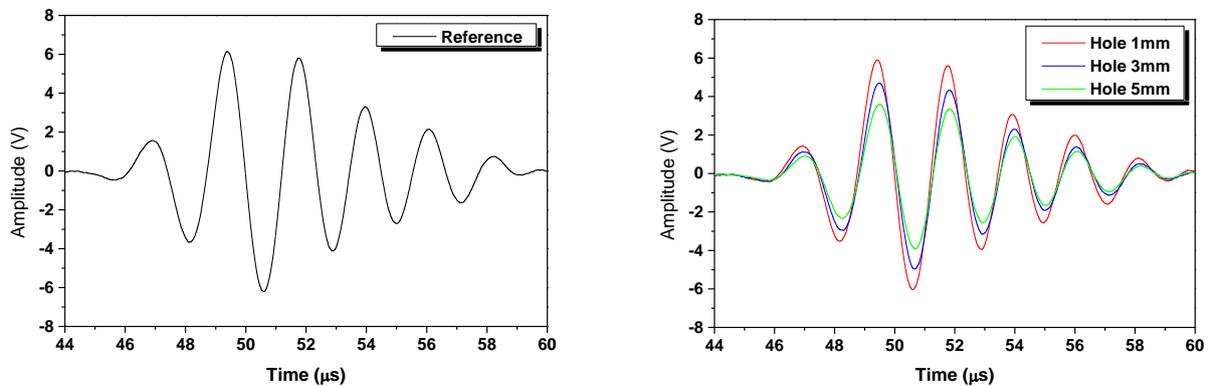
Figure 11. Reference time signal and signal for holes with different diameter (1mm, 3mm and 5mm)

For screening of the sensitivity of the Lamb mode S_0 to the occurrence of a localized defect of increasing size, we have chosen to introduce controlled diameter holes 1 to 10 mm in the plate laminated carbon / epoxy between the transmitter and the receiver. Figure 11 presents an example of a time domain S_0 Lamb wave obtained using the setup of Figure 5 for a reference plate (without any hole) and signal for holes with different diameter (1mm, 3mm and 5mm).

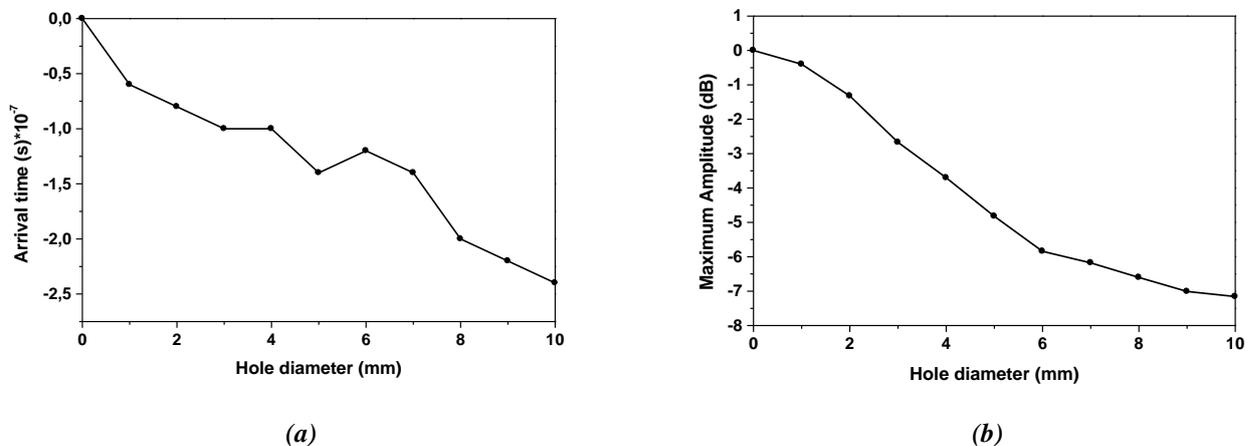
Figure 12 : Distribution of arrival time (a) and amplitude (b) of transmitted S_0 mode

Figure 12 presents the normalized amplitude and arrival time measurements for plate with holes with different diameters. We can see a decreasing in the received signal with the holes diameter increasing. This is comprehensible due to the increasing of the shadow zone where there is no direct transmission [11]. In the center of the plots, when the transducers are aligned with the holes is visible a local maximum that is related to the scattering effects.
